# ARBORICULTURAL REPORT

*Land at:*  
**Garstang Road,  
Broughton,  
Preston  
PR3 5JA.**

Prepared for:  
**Hollins Strategic Ltd**

Reference: AWA3718

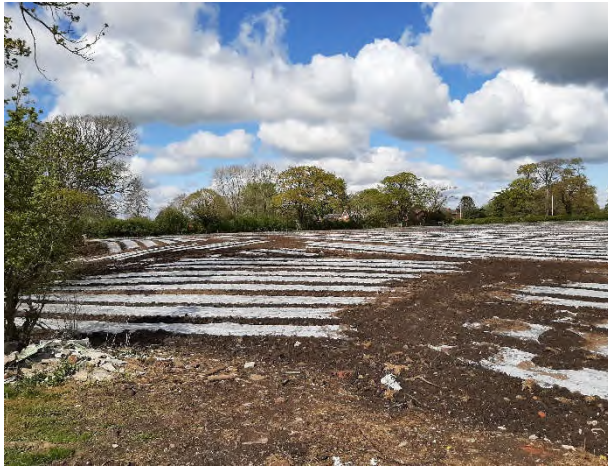
Photo 1: The site, as viewed from the access at Garstang Road

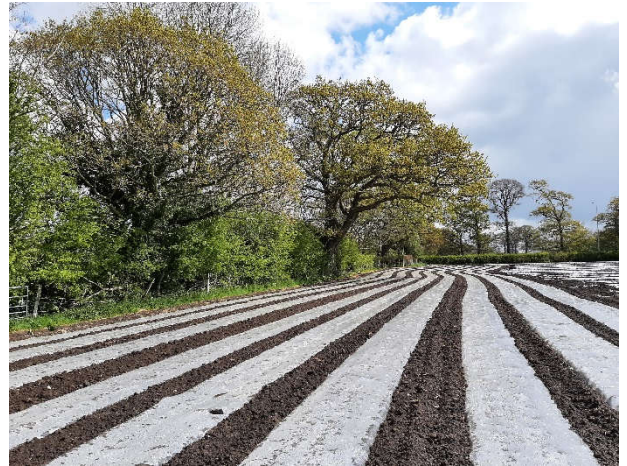
- 3.2.5 At the boundaries of the surveyed area there are a number of mature Oak trees; T3 to T6, T12, T13 at the northern boundary; T15 to T20 at the eastern boundary; T25 to T27 at the southern boundary and T41 and T44 at the west boundary. Of these trees, T3, T5, T12, T19 and T41 have high individual value, while the remaining trees have more moderate individual value. T13, situated just beyond the north-east boundary, shows signs of moderate dieback, with a relatively sparse crown and notable epicormic growth and saprophytic fungi in the crown, and so may have slightly more limited long-term prospects. However, the tree still provides moderate ecological value. T44, at the western boundary, has more limited landscape value due to its smaller size, being effectively screened by nearby vegetation.

Photo 2: G4, and large Oaks T5 and T6, at the northern boundary

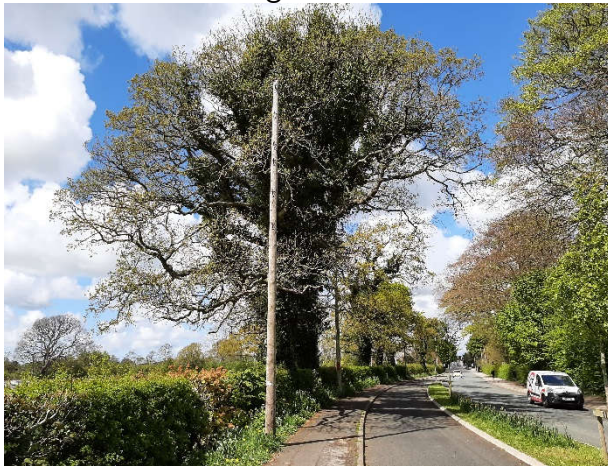
Photo 3: Mature Oaks T15 to T20, at the eastern boundary

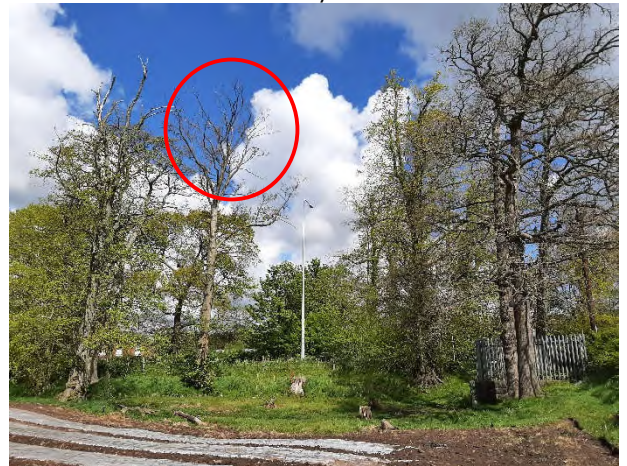
- 3.2.9 In the south-east corner, by what appears to be a dried pond with little remaining standing water, are T21 to T24, and T28. These are all large, mature trees with moderate amenity value. A number of the trees have defects that may indicate more limited long-term prospects. Sycamore T23 has notable dieback and deadwood in the crown, which overhangs the highway to the east, in addition to a slightly bulged base with some epicormic growth which suggests some decay in the lower stem. Remedial work will likely be required to retain T23 in the longer term. Limes T24 and T28 have prominent deadwood, with T28 in particular having a considerable amount of dead wood, likely due in part to its proximity to the regularly ploughed field.

- 3.2.13 T23 and T24 have prominent, moderate deadwood in the crown and are situated close to the highway, and so have an intolerable level of risk. Deadwood with the potential to fall into the highway should be removed (as detailed in Appendix 4).

Photo 4: T21 to T24, and T28, in the south-east corner of the site. Deadwood in T23 is circled in red

Tree ID	Tree Species		Maturity	Measurements				Crown (m)				Tree Condition						Value		Management		
	Common Name	Latin Name		Height (m)	Stems	Stem Diameter (mm)	Estimated	Ave Height	N	E	S	W	Roots	Stem	Crown	Comments	Physiological	Structural	Life Expectancy	Amenity	Category	Works
T23	Sycamore	<i>Acer pseudoplatanus</i>	Mature	17	1	690	No	3	3	8	3	3	Soil erosion, Exposed roots, Waterlogged	Single stemmed, Vertical, Epicormic growths	Moderate deadwood, Moderate dieback, Dead central leader	Large basal stem indicates potential rot at base. Epicormic at base prevented detailed inspection. Safe useful life expectancy could be increased by removing significant deadwood	Fair	Poor	10 to 20 yrs	Moderate	C	Remove deadwood over highway
T24	Lime	<i>Tilia x europaea</i>	Mature	21	1	900	Yes	2	5	5	5.5	5.5	Soil erosion, Exposed roots	Single stemmed, Vertical, Epicormic growths	Minor dieback, Minor deadwood, Dead central leader	Dense epicormic prevented detailed inspection	Fair	Fair	20 to 40 yrs	Moderate	B	Remove deadwood over highway

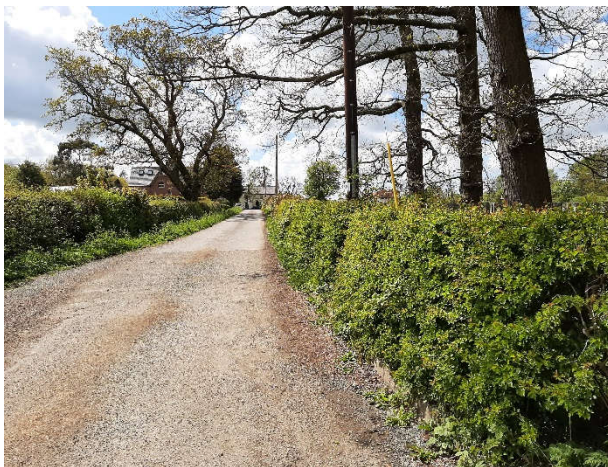
- 3.2.6 The mature Oak trees are typically situated in managed boundary hedges, including G1, G14, G29 and G30. These hedges are predominantly comprised of Hawthorn, with occasional other species. While these hedges have limited arboricultural value, they provide reasonable screening.

Photo 5: Managed hedge G29, at the southern boundary

G29	Hawthorn, Ash, Elder, Sycamore	<i>Crataegus sp.</i> , <i>Fraxinus sp.</i> , <i>Sambucus sp.</i> , <i>Acer sp.</i>	Semi-mature	2	10+	50 avg	No	0.5	See Plan				Boundary hedge on banking, south aspect regularly managed while north aspect bushy and unmanaged. Occasional ivy covered stem. Some Ash dieback				Good	Fair	>40 yrs	Low	C	No works required in current site context
G30	Hawthorn, Elder, Sycamore	<i>Crataegus sp.</i> , <i>Sambucus sp.</i> , <i>Acer sp.</i>	Semi-mature	2	10+	50 avg	No	0.5	See Plan				Boundary hedge on banking, west aspect regularly managed while east aspect bushy and unmanaged. Occasional ivy covered stem.				Good	Fair	>40 yrs	Low	C	No works required in current site context
T31	Horse Chestnut	<i>Aesculus hippocastanum</i>	Mature	15	1	870	No	2.5	4	6	5.5	4	Limited rooting area	Single stemmed, Vertical, Epicormic growths, Cup-like union collecting dirt/water	Well developed crown	In raised shrub bed, which will have limited root development	Good	Good	20 to 40 yrs	High	B	No works required in current site context

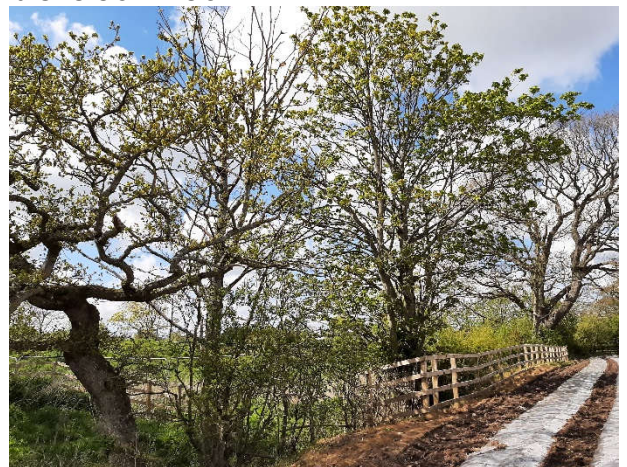
- 3.2.10 At the western boundary there is a number of trees situated on the banking of a small drainage channel; T42 to T46. Of these trees, Sycamores T42 and 43 have more moderate amenity value. Sycamore T45 had signs of significant dieback, and likely has very limited long-term value, although as it is currently situated in a very low target area it does not present an intolerable risk. The remaining trees have more limited value in the wider landscape, being screened by adjacent vegetation, but have reasonable screening value within the context of the surveyed area.

Photo 6: Smaller trees T44 to T46, at the west boundary

T44	Oak	<i>Quercus patraea</i>	Mature	8	1	450	Yes	3	3	3	4.5	4.5	Soil erosion, Exposed roots	Single stemmed, Slight lean east, Epicormic growths, Bark damage from grazing	Minor deadwood, Stubs, Snapped /hanging branches	Situated top of banking. Hanging branches and stubs from crown lifting.	Good	Good	>40 yrs	Moderate	C	No works required in current site context
T45	Sycamore	<i>Acer pseudoplatanus</i>	Early-mature	10	1	350	Yes	3.5	3	3	3	3	Limited access around base, Soil erosion, Exposed roots	Single stemmed, Vertical	Major dieback, Moderate deadwood	Situated on banking of drainage. Limited long-term value. Very low target value	Poor	Poor	<10 yrs	Low	U	No works required in current site context
T46	Sycamore	<i>Acer pseudoplatanus</i>	Early-mature	14	5	450, 250, 250, 250, 200	Yes	3	5	4.5	4.5	5	Limited access around base, Exposed roots, Soil erosion	Multiple stemmed at base, Epicormic growths, Pruning wounds from crown lifting	Minor dieback, Minor deadwood	Access prevented detailed inspection. Situated top of drainage banking	Good	Good	>40 yrs	Moderate	C	No works required in current site context
