## Appendix A

### Key Historic Buildings within the Conservation Area - Listed Buildings

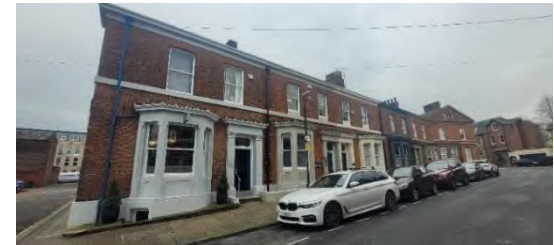
Five properties on a terrace, two-storeys over basement. Similar to others on Camden Place, particularly those opposite. Constructed of red brick (Flemish bond) with a slate roof. Stone detailing (painted). Mostly timber 1 over 1 sash windows, with the exception of 6 over 6 to ffl of No.8 & 10 and modern timber casements to ffl of No.9. Traditional style timber doors, with transom windows. Repetitive style, with decorative stone details, including canted bay windows, door surrounds, cornice, band to FF, sills. Arched brick lintels to FFL. Retained chimney stacks and some pots. Small stone boundaries retained on all but No. 6. Occasional concrete steps replace original stone, No.6 tiled. All appear to have office/commercial use.

Forms part of a row of terrace properties, provides collective character. Properties similar in design, retaining most original features and are part of C19 expansion of the town (now City).

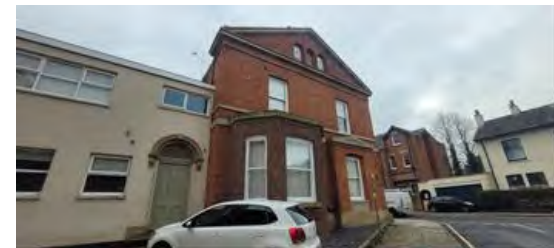
#### 11 Camden Place

Two-storeys (rear part) and two-storey with attic. Constructed mostly of Flemish bond red brick with the exception of the canted bay window on Camden Place, which is Stretcher bond. Two-storey element is finished in render, painted cream. Stone detailing (painted). Slate roof. Timber 1 over 1 sash windows to brick part of building, white modern uPVC casements to rendered part. Traditional style timber door, with fanlight. Built in Classical style, with decorative stone details, including, arched door surrounds, gable pediment, bands and string course to FF, sills, brick lintels. Lunette window to attic on Ribblesdale Place elevation. Retained chimney stacks. All appear in residential use.

Largely retained its external features to brick part but rendered part substantially modernised, which detracts. The larger brick bay window is a later addition and would originally have matched the adjacent square bay, this is evidenced on the early town maps (1840s).

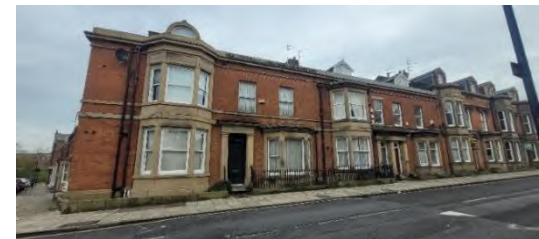
### **26-28 Ribblesdale Place**

Two-storeys with attic and basement. Retained most original features. Constructed of red brick (Flemish bond) with slate roof. Timber 1 over 1 sash windows. Traditional style timber doors, with transom windows. Stone detailing, including canted bays, sills, string, band courses, door surrounded with dentilled detail, eaves cornice (some painted). 1 x stone wedge lintel to FFL No.27, rest brick. Retained chimneystacks. No.27 & 28 have small dormer windows. Small stone front boundaries, No. 26 & 27 have iron railings, unclear if original. All appear in residential use.

Forms part of row of terrace properties, one of which also fronts Camden Place. Provides collective character. Part of C19 expansion of the town (now City). One of the earlier properties on the street, and identified on the first ed, town map (1840s-60s)

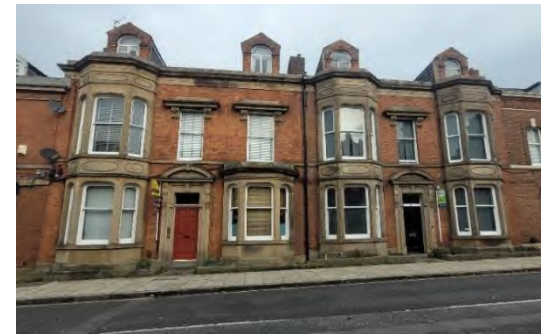
### **29-29a Ribblesdale Place**

Two-storeys with attic, part of a row of terrace properties, different styles. 2 separate properties. Double fronted. Constructed of red brick (Flemish bond) with a slate roof. Decorative stone detailing. Curved timber 1 over 1 sash windows. Traditional style timber doors, with transom windows. Polychrome brick to attic dormers (red & blue?), vertically hung slates to sides. Decorative stone details, including canted bay windows (all but 1 double), decorative door surrounds with segmental pediment and window hoods, deep eaves cornice, sill band to FF. Retained chimneystacks. Small stone boundaries retained, no railings. Retained most original features. All appear to have residential use.

Forms part of a row of terrace properties, provides collective character, but differ in style. Part of C19 expansion of the town (now City). Later buildings on the row, identified on the 1840s-90s town map, not the earlier 1840s-60s.

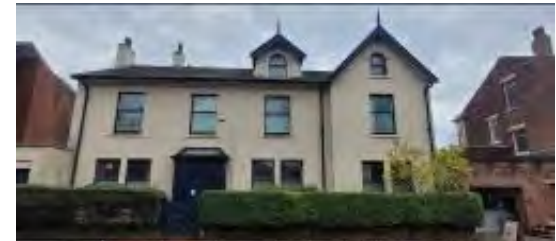
### **12 Ribblesdale Place**

Two-storeys with attic, front-facing projecting gable and 1 x attic dormer windows, 4-bay detached property, different in style than majority of other buildings on this street. Most likely built from brick, now rendered with a slate roof. Some stone detailing evident under render to the dormer windows, with arched detailing. Timber 1 over 1 sash windows, curved in attic/dormer. Timber porch with traditional style timber doors, with transom windows. All timber painted blue. Stone details (curved) evident to attic windows under render. Timber finials to timber fascia's on dormer and gable. Retained chimneystacks. Most original features either lost or hidden. Small stone boundaries retained, with box hedges, which clearly define the garden space. Retained timber gate and posts, possibly original.

Use unclear, small sign on front elevation for Society of Saint Pius X. Once the home of Nathaniel Miller and family, who was a dentist but also financed the construction of Preston's Miller Arcade, to who it is named after.

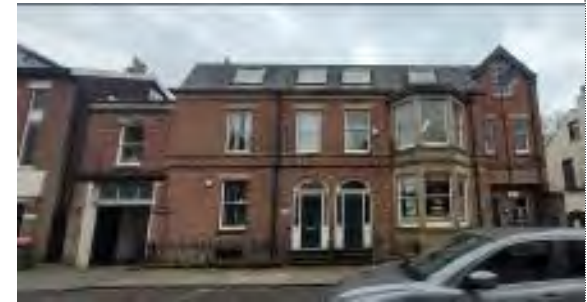
Small stone boundaries retained, railings, which are replacements. One of the modern extensions less visually attractive, vehicle access to rear visually detracts.

Originally semi-detached, now appears more of a terrace due to side extension and additional entrance door. Provides collective character. Part of C19 expansion of the town (now City). Earlier building on the street, identified on the 1840s-60s map.

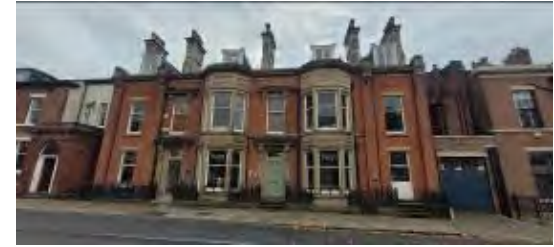
### **6-7 Ribblesdale Place**

Two-storeys with attic and basement, double-fronted, semi-detached properties. Constructed of red brick (Flemish bond) with a slate roof. Timber 1 over 1 sash windows. Traditional style timber doors, with transom windows. Timber decorative attic dormers, with vertical hung slates to sides. Decorative stone details, including canted double height bay windows, decorative door surrounds and window hoods, deep eaves cornice, decorative stone kneelers, sill band to FF. Retained long chimneystacks, which are constructed from or faced in stone or buff brick? Small stone boundaries retained, with highly decorative iron railings. Concrete steps replace original stone, No.6. Commercial use.

Largely retained most of its external features. Similar in design to those on opposite side, slightly to the west (No.29 &29a).

Provides collective character. Part of C19 expansion of the town (now City). Earlier buildings on the street, identified on the 1840s-60s.

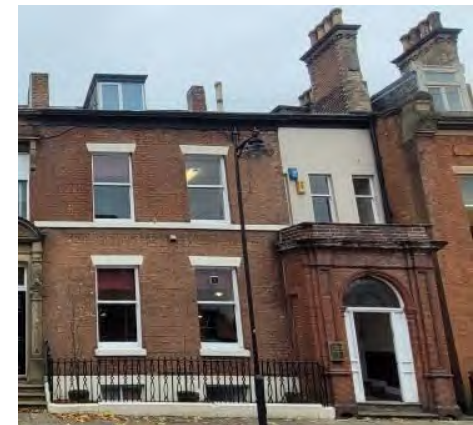
### **5 Ribblesdale Place**

Two-storeys with attic and basement, part of a terraced row. Constructed of red brick (Flemish bond) with a slate roof. Timber 1 over 1 sash windows, 1 white uPVC to dormer. Stone sills and wedge lintels, sill band to FFL. Large Terracotta entrance porch. Render to set back bay and ground floor. Simplistic architectural style, with the exception of decorative terracotta entrance porch. Stone details, including eaves cornice, sill band to FF. Retained chimneystack, no pots. Largely retained most of its external features. Commercial use. Small stone boundaries retained, with decorative iron railings.

Provides collective character. Part of C19 expansion of the town (now City). Earlier buildings on the street, identified on the 1840s-60s.

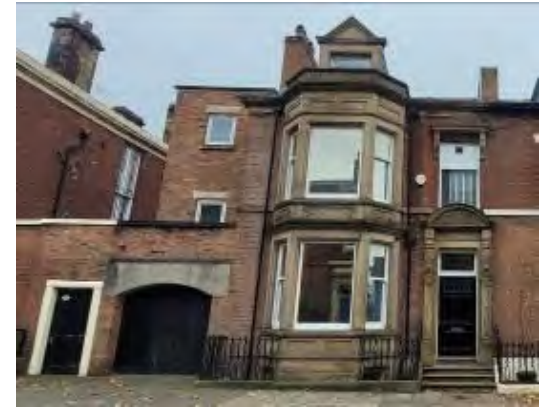
#### 4 Ribblesdale Place

Two-storeys with attic and basement. Part of a terraced row. Constructed of red brick (Flemish bond) with a slate roof, later extension stretcher bond. Decorative stone dressings. Timber 1 over 1 sash windows and casement windows to central sections of bays, possible white uPVC to dormer, difficult to see, white uPVC to later extension. Stone sills and wedge lintels to side extension, sill band to ffl. Timber period style front door, with leaded transom window. Decorative classical architectural style, with the exception of side extension. Decorative stone details, including door surround with segmental arch, hoods to windows and deep eaves cornice, sill band to FF and stone faced dormer, with vertical hung slates to the side. Retained chimneystack and pots. Small stone boundaries retained, with decorative iron railings. Brick screen with timber entrance gates. Retained most original features. First ffl window altered and partially blocked up with a vent and alarm box detracts slightly. Use unclear, possible commercial use.

Part of C19 expansion of the town (now City). Earlier buildings on the street, identified on the 1840s-60s, at the time was semi-detached property, by 1840s-90s town map, become terraced. Provides collective character.

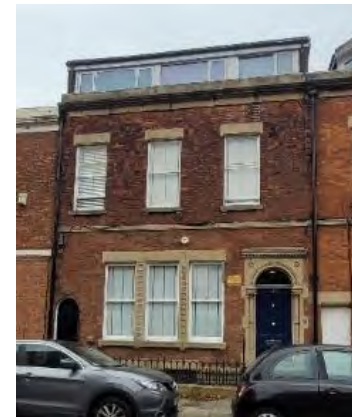
#### 6a Starkie Street

Two-storeys with attic and basement, part of a row of terrace properties, slightly different in style. Red brick – Flemish bond and a slate roof. Decorative stone detailing. Timber 1 over 1 sash windows. Traditional style timber door, with fanlight. Decorative stone details, including mullions to GF windows, decorative arched door surround, deep eaves cornice, sills and lintels, band to FF. Small arched access door to rear. Small stone boundaries retained, with railings. Retained most original features. Large modern dormer roof, spanning width of property, detracts. Alarm boxes and electrical wires, which detract very slightly. Largely retained most of its external features. Appears to have residential use.

Part of C19 expansion of the town (now City). Later buildings in the CA, identified on the 1840s-90s town map, not the earlier 1840s-60s. Forms part of a row of terrace properties, provides collective character, but differs in style slightly.

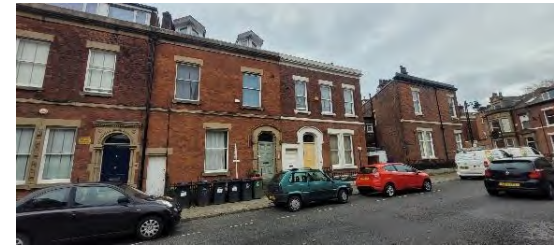
To let signs that appear to be a permanent feature as showing on google maps since 2020. Alarm boxes and electrical wires, detract very slightly. Bins in front of both properties, but a long row of bins in front of No7, which detract. Stone work on No.8 painted and maintained which detracts. Appears to have residential use. No.7 HMO has a flat style door bell. Largely retained most of its external features.

Part of C19 expansion of the town (now City). Later buildings in the CA, identified on the 1840s-90s town map, not the earlier 1840s-60s. Forms part of a row of terrace properties, provides collective character, but differs in style slightly.

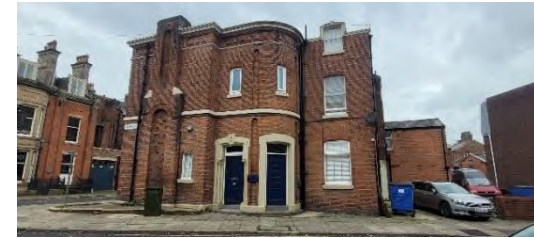
### **9 Starkie Street**

Non-timber windows detract. Alarm boxes, electrical wires and satellite dish, detract very slightly. Rear/side open and hard surfaced, with patchy brickwork repairs and bin storage, which detract.

Part of C19 expansion of the town (now City). Later buildings in the CA, identified on the 1840s-90s town map, not the earlier 1840's-60s. Forms part of a row of terrace properties, provides collective character, but differs in style slightly.

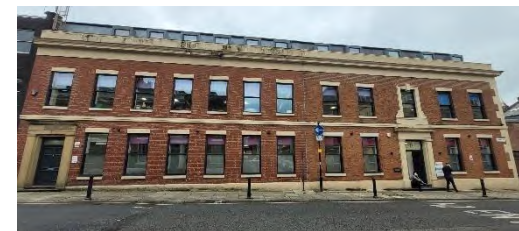
### **12-13 Starkie Street**

Two-storeys with attic, part of a long row, 2 separate properties. Modern extensions added to the rear. Long rows of windows. Red brick – Flemish bond, modern roof difficult to see, possibly steel panelled. Stone detailing. Timber 1 over 1 sash windows. Traditional style timber doors, with transom windows. Modern sashes, painted positive. Decorative stone detailing, including sills and, lintels - wedge lintels to No.13, base plinth, deep eaves

cornice, band and decorative stone entrance doors, No.13 more impressive than No.12 doorway as runs into decorative FFI window.

Whilst large properties, possibly always of a commercial use, they reflect the long rows of terraced properties elsewhere, not put of place, as street is mixed scale, mass and style. Office use. Largely retained most of its external features Well maintained properties. Both restored, No.11 looks like bricks have been replaced or restored. Alarm boxes and commercial signs, which detract very slightly.

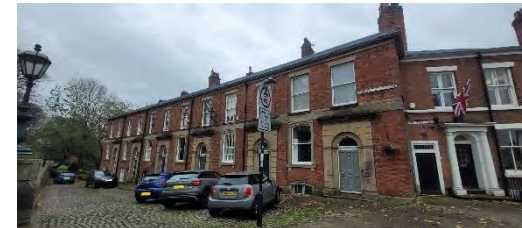
Two-storeys with basement, some with attic dormers, part of a row of terrace properties, repetitive styles. 5 separate properties. Fronts pavement. Red brick – Flemish bond and a slate roof. Stone detailing. Mostly timber 1 over 1 sash windows, with some 6 over 6 (No.2). Traditional style timber doors, with fanlights. Stone details, including, decorative rusticated door surrounds with wedged lintels, sills, eaves cornice, bands to FF. Retained chimneystacks.

Fronting road setts, visually nicer and runs down to entrance of Avenham Park. All appear to have residential use. Largely retained most of its external features. Adjoins Avenham Park with entrance to the park at the end of the row of Avenham Colonnade.

Part of C19 expansion of the town (now City). Earlier buildings on the row, identified on the 1840s-60s. Forms part of a row of terrace properties, provides collective character.

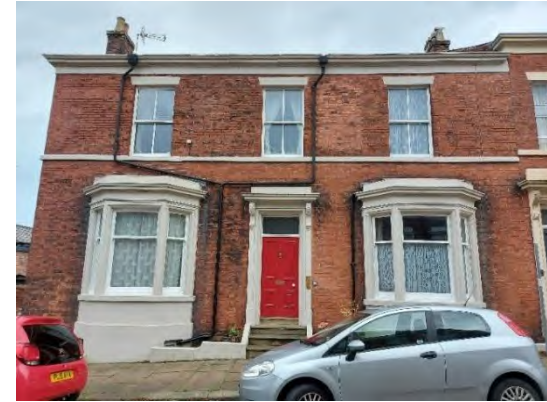
### 3 Bairstow Street

Two-storey plus basement. Corner of a terrace that continues all along Bairstow Street. Double-fronted. Canted bay windows on ground floor on either side of the central entrance. Rear garden accessed from the side (continuation of Bairstow Street). Very small extension to the rear (not visible from the street; can see from Mario Maps). Red brick (Flemish bond). Classical style sandstone dressings. Slate roof. Red brick chimney stack on left edge with two clay chimney pots (different styles: round base and square base). Timber 2 over 2 sash windows with horns. Three-stepped central entrance with nosings. Canted bay windows on ground floor (principal elevation) with parapets on top. Wedged lintels on all other windows. First-floor raised sill-band. Four-panelled door (red) with transom window (overlight). Doorway has a stone surround with a cornice hood carried on brackets/consols. Plain frieze and moulded gutter cornice. Original chimney stack, stepped with dentils at the top. Black uPVC rainwater goods.

Pale brick section to the right of central window on first floor but no change in brick pattern (possibly closed smaller window?). Building compliments the rest of the terrace. Mock windows but visually in keeping.

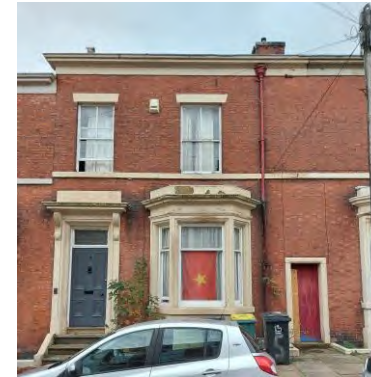
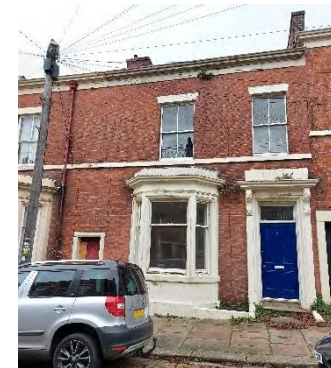
Brick has black discoloration around the cornice hoods above doors and to the sides of the canted bay window parapet. No.7 is vacant and in poorer condition with rotten timber window frames, vegetation growth over cornice hood and on moulded gutter cornice. Cables and alarm box detract slightly.

The building is in its original form. Bairstow Street was developed after the 1850s (there are no roads between Chaddock St and Camden Place in the 1849 OS Map). The buildings on this street consist of terrace houses. Collective character as mid-19th-century terrace housing in central Preston. Identical detailing throughout No3-11. Identical to No.10-28 on the opposite side of terrace.

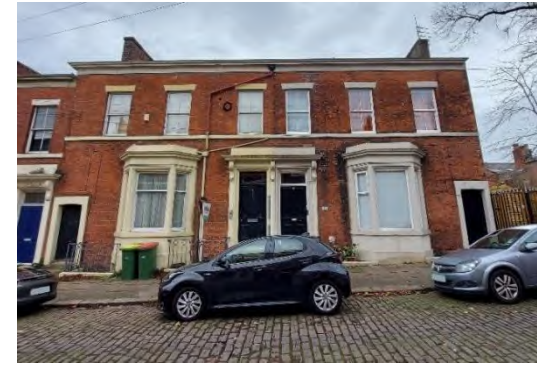
### **9-11 Bairstow Street**

Pair of terrace houses with through-lobbies at the outer ends. Two-storey plus basement. Single-fronted, with doorways coupled at the centre. Canted bay windows on ground floor on either side of the central entrance. Next to a gap in the terrace that has existed since the terrace houses on this street were built. Red brick (Flemish bond). Sandstone dressings (No.9 painted light yellow). Slate roof. Red brick ridge chimney on the right. Timber two over two sash windows (No.9 with horns). No.11 upper windows uPVC. Iron and uPVC rainwater goods. Iron railings around basement on No.9. Iron lock plate on the ground in front of through-lobby door of No.11 (possibly also at No.9 but this is covered).

The building is in its original form. No. 9 is converted into flats. Bairstow Street was developed after the 1850s (there are no roads between Chaddock St and Camden Place in the 1849 OS Map). The buildings on this street consist of terrace houses.

Collective character as mid-19th-century terrace housing in central Preston. Identical detailing No3-11.

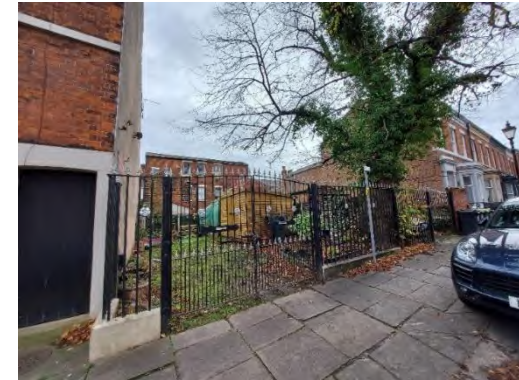
### **Area between 11 and 17 Bairstow Street**

This is a historic gap in the terrace on Bairstow Street that is being used for garden/garage purposes. It is the size of approximately two plots and corresponds to what would have been No.13 and No.15 Bairstow Street. There is a tree at the center of the two plots. The area was originally surrounded by a wall (OS Map 1890s). It still has a brick wall next to No. 17 Bairstow St and the southwestern corner. Part of the brick wall adjacent to No. 11 is lost. The rear wall also appears to have been lost or covered with timber fence. The side facing the street has iron railings (also on top of the brick wall adj to No.17). Historic brickwork as well as modern railings, timber fences.

Overall this area is an open space within the rigidity of the terrace. The area retains its original size. The plot next to No.11 is used as a garden and has a timber shed (built between 2020-2022). The plot next to No.17 has a brick garage with a low-pitched roof.

The gap has existed since Bairstow Street was developed in the second half of the 19th century. It is shown on the 1890s OS Map including the tree at the junction of the two plots. The house numbers on either side of this gap (No.11 and No.17) relate to these two plots.

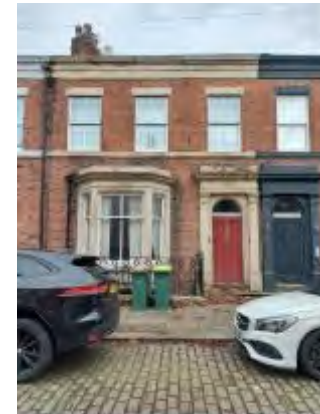
### **17-19 Bairstow Street**

Two-storey plus basement. Single-fronted with canted bay windows on ground floor. Narrow alley to the left of No.17 leading to the rear garden. Red brick (Flemish bond). Sandstone dressings. Slate roof. Red brick ridge chimney at the centre with varying chimney pots. Timber two over two sash windows (6 window range). Iron rainwater goods. Iron railings (most likely original) around basement on both No.17 and No.19.

Black discoloration, vegetation growth above cornice hood on No.19. Aerial on roof.

The building is in its original form. Bairstow Street was developed after the 1850s (there are no roads between Chaddock St and Camden Place in the 1849 OS Map). The buildings on this street consist of terrace houses. Collective character as mid-19th-century terrace housing in central Preston. Identical detailing with No21-23.

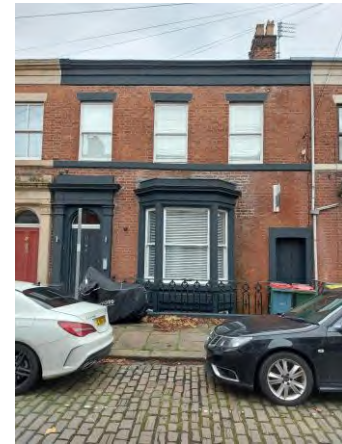
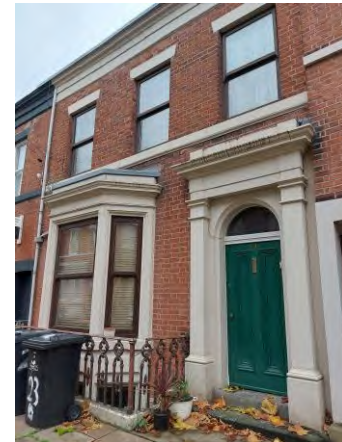
### **21-23 Bairstow Street**

Two-storey plus basement. Single-fronted with canted bay windows on ground floor. Through-lobby at the center. Red brick (Flemish bond). Sandstone dressings. Slate roof. Red brick ridge chimney at the centre with varying chimney pots. Timber two over two sash windows (6 window range) uPVC rainwater goods. Iron railings (most likely original) around basement on both No.21 and No.23.

Charcoal-painted sandstone dressings at No.21 and dark brown window frames at No.23 out-of-character with the conservation area. White and black discolouration at No.21. Aerial on roof.

The building is in its original form. Converted into flats. Recently done up. Bairstow Street was developed after the 1850s (there are no roads between Chaddock St and Camden Place in the 1849 OS Map). The buildings on this street consist of terrace houses. Collective character as mid-19th-century terrace housing in central Preston. Identical detailing with No.17-19.

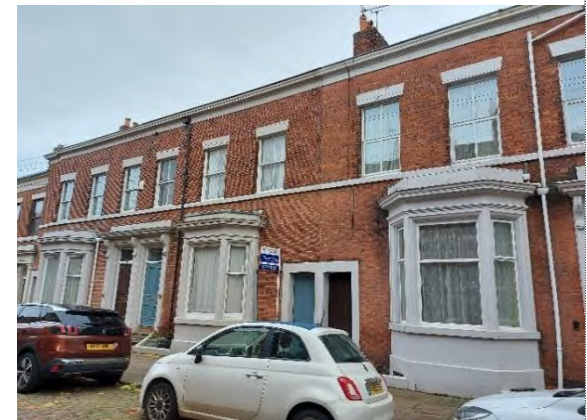
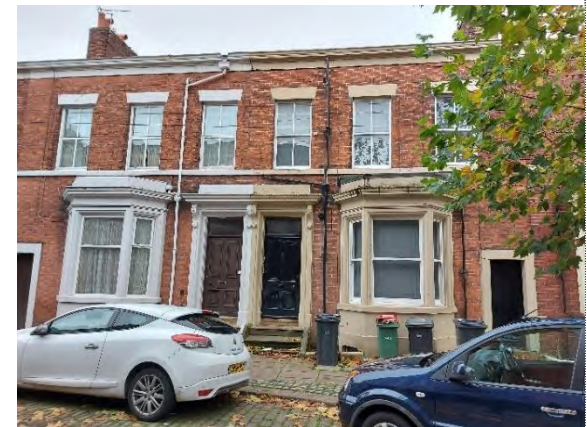
### **25-31 Bairstow Street**

Two pairs of terrace houses with through-lobbies at the outer edges. Two-storey with a basement/cellar. Single fronted with canted bay window on ground floor. Paired doorways at the junction. Red brick (Flemish bond). Sandstone dressings (painted light yellow at No.31). Timber two over two sash windows. Slate roof. Red brick chimney stack over ridge and four clay chimney pots (different styles). Iron rainwater goods. Iron lock plate on the ground in front of through-lobby doors except No.31.

Brick has black discoloration around the cornice hoods above doors and to the sides of the canted bay window parapet. Cables and alarm box detract slightly.

The building is in its original form. Loss of railings. Bairstow Street was developed after the 1850s (there are no roads between Chaddock St and Camden Place in the 1849 OS Map). The buildings on this street consist of terrace houses. Collective character as mid-19th-century terrace housing in central Preston. Stylistically identical detailing with No.3-11.

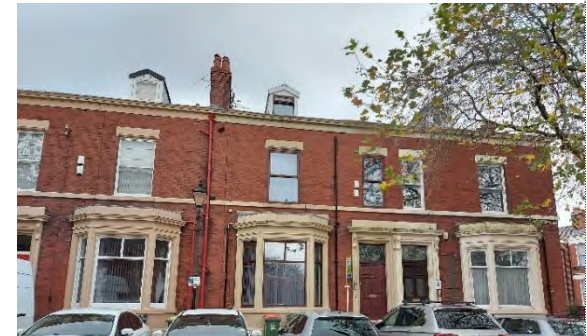
### **33-39 Bairstow Street**

Two pairs of terrace houses on the corner of Bairstow Street and Avenham Lane. Single fronted with canted bay windows on ground floor. Paired doorways at junction. Red brick (Stretcher bond). Sandstone dressings (painted light yellow at No.31). Timber 2 over 2 mock sash windows. Slate roof. Red brick chimney stack at the junction of two pairs and on the right gable. Iron rainwater goods. Iron lock plate on the ground in front of through-lobby doors except No.31.

Brick has black discoloration around the cornice hoods above doors and to the sides of the canted bay window parapet. Cables and alarm box detract slightly. The rear garden of No.39 is accessible from Avenham Lane via a board door. A uPVC shed? is visible above the brick garden wall, which detracts from the character of the CA.

The building is in its original form. Loss of railings. This part of the terrace is the latest to be built (between 1895 and 1913), having replaced a detached house called “Avenham House” (this house is seen in the 1849 OS Map and predates the development of Bairstow St). Demolished possibly in the early 20th century (last seen in 1895 OS Map).

This part of the terrace differs from the rest in that it does not have wedge lintels or Flemish bond. The window proportions are different (wider above the doorway with a narrow window to its side as opposed to same sized windows on first floors).

Although it resembles the stylistical detailing of No.3-11 and .25-29, this part of the terrace is slightly different.

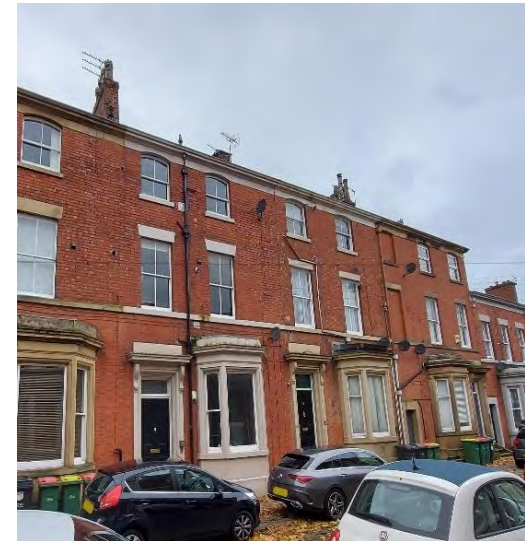
### **30-34 Bairstow Street**

Original form. Flats. In good condition. Aerials on chimneys, satellite dishes (3 on No.30, 1 on No.32, 2 on No.34) and uPVC downpipes and top windows on No.30 detract.

Three storeys high on an otherwise two-storey street. Other than the third floor, the style is identical to the other buildings on this street. Bairstow Street was developed after the 1850s (there are no roads between Chaddock St and Camden Place in the 1849 OS Map). The buildings on this street consist of terrace houses. Contributes to the general character of the area.

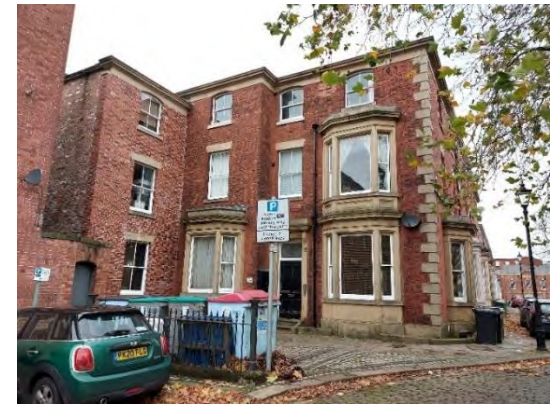
### **36 Bairstow Street**

Corner/end of terrace adjacent to No.30-34. Three-storey with basement/cellar. Has two elevations (principal elevation looking towards Avenham Lane, side elevation facing Bairstow Street). Double-fronted (looking towards Avenham Lane) and single bay facing Bairstow St. Principal elevation: central doorway with canted bay window on the right (gf and ff) and left (gf)). Side elevation: canted bay window on gf. Three-storey extension to the southeast. Red-brick (Flemish bond) with sandstone dressings. Timber two-over-two sash windows and slate roof.

The building was extended with a three-storey extension possibly in the late 19th or early 20th century. The extension has identical architectural features, therefore compliments the original building. Brick repair under the frieze (noticeable brick and mortar). One aerial to the right on gf, near the corner of the building.

As a three-storey corner building, architecturally it significantly contributes to the character and appearance of the CA. Stylistic similarities but different spatial arrangement from the rest of the terrace (corner building with two elevations).

Used as flats. Bairstow Street was developed after the 1850s (there are no roads between Chaddock St and Camden Place in the 1849 OS Map). The buildings on this street consist of terrace houses. Very small yard/passage with brick boundary wall between No.36 and No.38 with segmental arch doorway with coping above, facing Bairstow Street. Provides access to the rear yard of No.34.

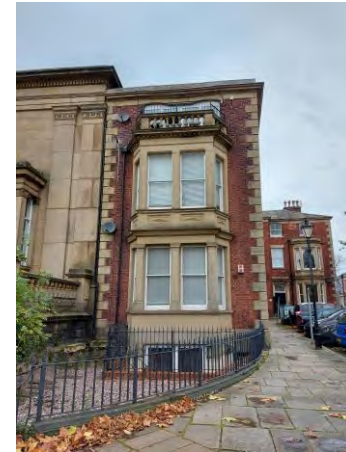
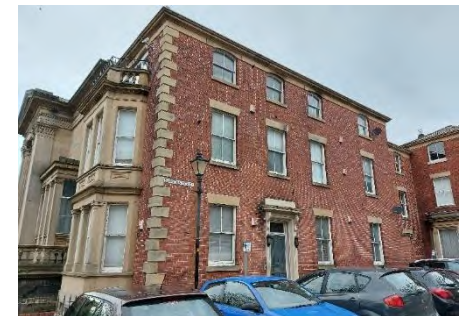
### 38 Bairstow Street

Adjacent to the Harris Institute. Three-storey with basement/cellar. Has two elevations (looking towards Avenham Lane and facing Bairstow Street). Four bays on Bairstow St with entrance on second left and single bay facing Avenham Lane. Doorway on Bairstow St. Avenham Lane elevation: canted bay window on gf and ff. Red-brick (Flemish bond) with sandstone dressings. Timber two-over-two sash windows except bay windows (one over one) and slate roof. Cellar windows facing Avenham Lane in uPVC. Railings above ff canted bay window.

Original form. Second floor windows facing Avenham Lane altered - lost brick mullion in between. The enlarged opening serves as window/door to the top of ff canted bay window. Balustrade has an iron railing added to it. 2 aerials in each elevation and security camera, alarm box, which slightly detract.

Bairstow Street was developed after the 1850s (there are no roads between Chaddock St and Camden Place in the 1849 OS Map). The buildings on this street consist of terrace

houses. Contributes to the general character of the area. Stylistic similarities with other buildings on this street but stands out as a building attached to Harris Institute

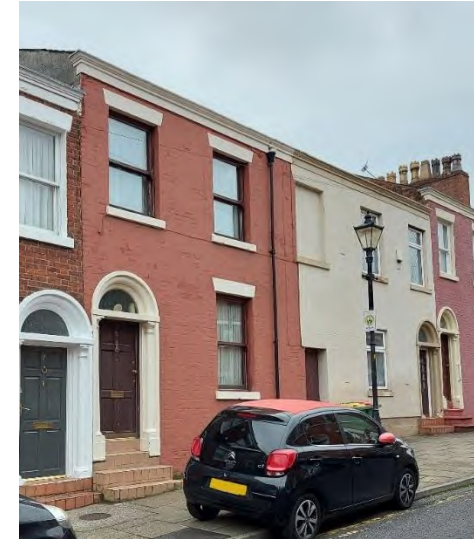
### **8-9 Chaddock Street**

Doorway steps covered with beige and reddish tiles, uPVC windows, alarm box detract. Steps, door (No.9), fanlight, and windows altered. Chimney stack removed.

Built c.1830. Forms part of an almost complete set of late Georgian lower-middle class houses in this street. The pair is in between two pairs of listed townhouses.

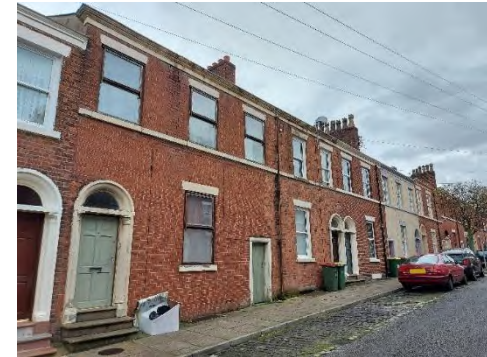
### 12-15 Chaddock Street

No.12 and 13 look run down, black discoloration along rain pipe, large-scale discoloration along the eave. No.14 and 15 good condition.

In its original form. Altered windows, removed cellar window. Built c.1830. Forms part of an almost complete set of late Georgian lower-middle class houses in this street. The pair is in between two pairs of listed townhouses.

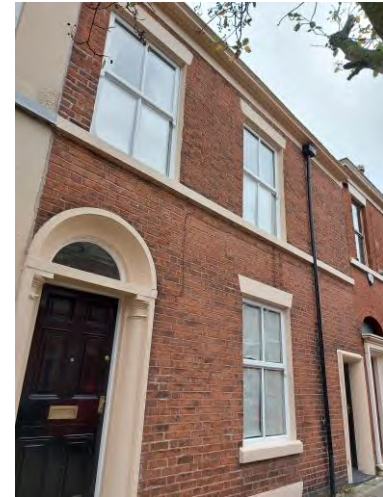
### **16 Chaddock Street**

Two-storey over cellar. Part of a terrace. Single-fronted with through-lobby to the right. Red brick (Flemish bond) with sandstone dressings and slate roof with brick chimney stack. Timber mock-sash windows (two over two). Doorway with two steps (lower one with nosing). One window at ground floor and two above. All windows wedge lintels; gf with raised sill; ff sill band. Casement cellar window with wedge lintel and gratings. Plain frieze and moulded gutter cornice. Doorway with round-headed architraves with set-in Tuscan quarter-columns, plain lintels, and semi-circular fanlight with convex moulded surrounds (door six-panelled). Lobby doorway with curved surround and board door. Iron rainwater goods. Windows altered, which slightly detract. Good condition, some black discoloration at ground level. In its original form. Built c.1830. Forms part of an almost complete set of late Georgian lower-middle class houses in this street. Has similar style with 12-15 Chaddock Street.

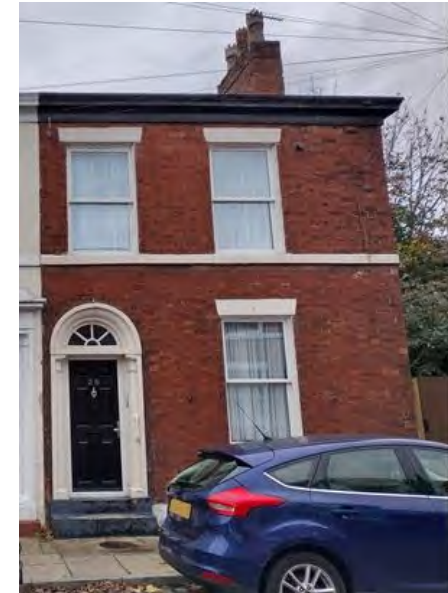
### **25 Chaddock Street**

Doorway with two steps, altered. One window at ground floor and two above. All windows with wedge lintels, gf windows with raised sills, ff with sill band. Casement cellar window not visible but grating is. There is a plinth on the gf. Plain frieze and moulded gutter cornice. Doorway with round-headed architraves with set-in Tuscan quarter-columns, plain lintel, and semi-circular fanlight with convex moulded surrounds (door six-panelled). Doorways steps altered. Windows changed to uPVC windows possibly within the last decade (six over six originally). Steps altered and handle added to the column. Windows uPVC but visually not too compromising.

Built c.1830. Built with most of the rest of the buildings on this street but there was a gap to its left until the second half of the 19th century (No.22-25). Forms part of an almost complete set of late Georgian lower-middle class houses in this street.

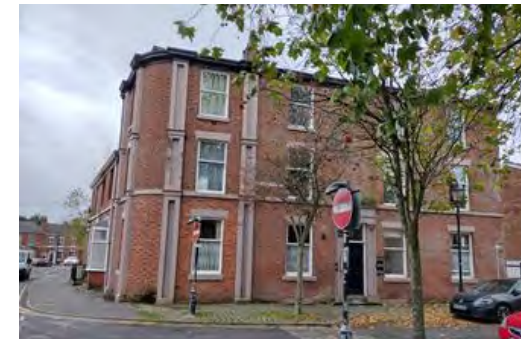
### **27-27a-27b Chaddock Street**

On the corner of Chaddock Street and Avenham Lane. Adjacent to 11-15 Avenham Lane. Three-storey over cellar with entrance from Chaddock Street. Red brick (Flemish bond) with sandstone dressing (painted grey-pink) and slate roof with brick chimney stack. Timber mock sash windows.

Unusual double pilaster / panel-like features on both elevations. Doorway with panelled pilasters and cornice above plain architrave and frieze. Six panelled door with transom window. Wedge lintels in cellar, gf and ff, windows under the eave on sf raised sills on gf and sf, ff sill-band. Deep eave cornice.

Aesthetically, the building is quite different from contemporary buildings due to the double-pilaster /panel? features. The most major change since its construction in the early 19th century is that this building originally had two-storeys but possibly still in the 19th century another floor was added with the same architectural features (photo from 1862). Originally, there was also a door in the rounded off corner, of which there is no trace. Poor condition brick especially on Chaddock Street elevation + microbiological growth.

Now used as flats. The building dates to early 19th century and was built with 11-15 Avenham Lane (same doorway composition). Group value with 11-15 Avenham Lane.

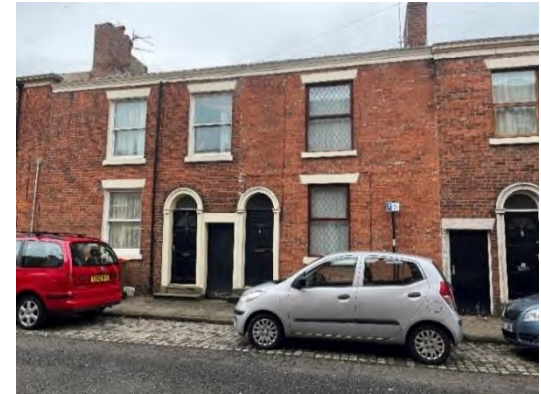
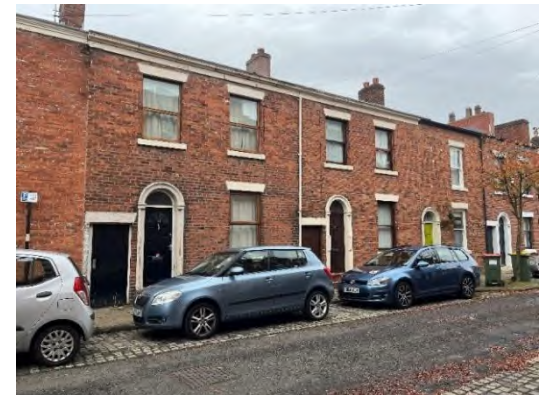
### **27-43 Great Avenham Street**

Nos.27-43 Great Avenham Street are a row of terraced dwellings, they all follow the same design and form and as such there is not conflict between the buildings and they sit well along the street. The row is constructed from red brick with stone detailing. The dwellings are in an overall good condition, however there are some slight maintenance issues such as flaking paintwork and damp to the brickwork. No. 39 has had its brickwork painted red and no.43 has been rendered and painted cream, which disrupts the uniformity.

The brickwork alters along the row, and includes English garden wall bond and stretcher bond, the red brick colour also changes along the row. None of the windows appear to be original and are mainly mock sash in timber or uPVC. The front doors are mainly six panel timber doors, some of which are an arched window detail. The doors have an arched carved stone door case with a fanlight, this detail can be found across the row.

The building appears on the 1840s map and its use as a dwelling is still evident. The building reflects the historic expansion on the area. The overall form and arched door detail creates collective character between the dwellings and as such they have a good amount of group value.

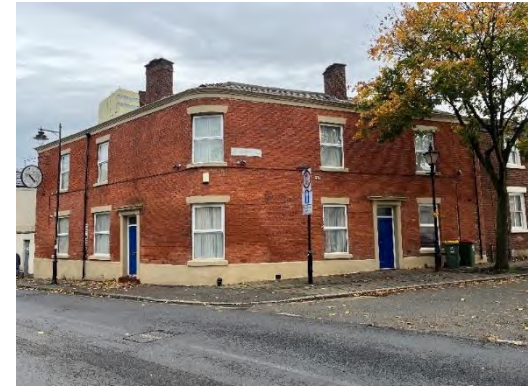
### **36 Avenham Lane**

No.36 Avenham Lane is a large corner building with elevations on both Avenham Lane and Frenchwood Street, it is appropriate to its plot and has no conflict with neighbouring properties. It is slightly larger in scale than the neighbouring terraced buildings. No.36 Avenham Lane is constructed from red brick in an English garden wall bond with stone dressings. It is in good, uniform condition. The building has two entry doors, one of Avenham Lane and one on Frenchwood Street, both with a detailed simple stone surround with a moulded projecting cornice. It has stone lintels and sills to the windows and a large stone plinth. It has timber four panelled doors and mock sash timber windows, these do not appear to be original. The brickwork on the corner where Frenchwood Street meets Avenham Lane is curved.

The brickwork and stone dressings compliment the buildings found elsewhere in the conservation area. Despite not being original, the windows and doors do not detract from the character or appearance of the conservation area.

No.36 Avenham Lane is somewhat unique in its design, differing slightly from the neighbouring terraced properties. It has collective character in its use of brick and stonework.

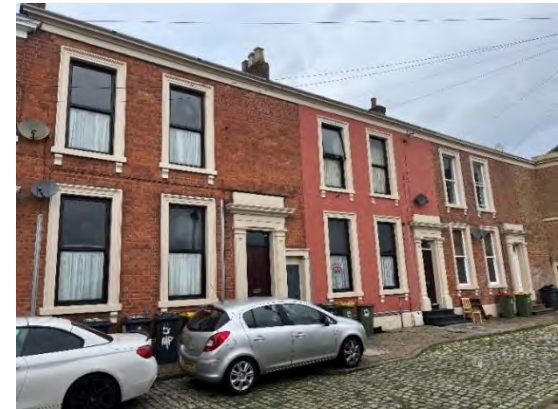
### **3-5 Avenham Place**

3-5 Avenham Place is a row of two storey terraced dwellings, they are an appropriate size for their plot and relate to the adjacent terraced buildings along Avenham Place. There is no conflict between their scale and size. The row is constructed from red brick with stone detailing, although no.4 is rendered and painted. Generally, they are in a good and uniform condition. The row has a good level of stone detailing, the door surrounds have pilasters with a plain frieze, moulded cornice with blocking course above. The brickwork is in English bond. Windows are sash/mock sash one-over-one and of timber, the front doors are a six panelled and of timber.

The materials compliment the other buildings found elsewhere in the conservation area. The windows and doors do not necessarily detract from the character or appearance of the conservation area as they are timber, though those at nos.3 and 4 are dark stained wood/black which differs from the neighbouring properties. There are some wires across the facades of the building as well as satellite dishes, which detract from the appearance of the row.

The buildings appear to retain their use as dwellings and are largely in their original form although most, if not all, of the windows and doors appear to be unoriginal. The group of dwellings were built in the mid-late 19th century, slightly later than the buildings found elsewhere in this area. They reflect the continued expansion of Avenham during this time period. The dwellings have group value and collective character and detailing.

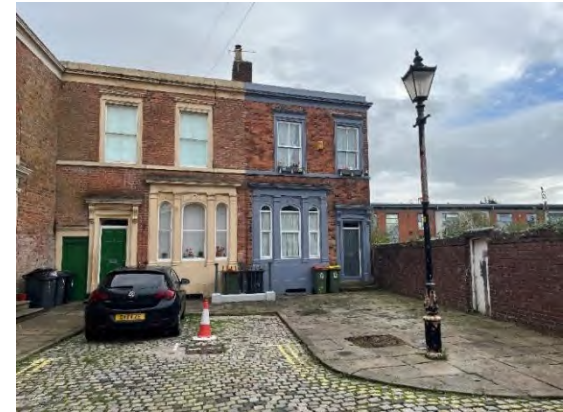
### **6-7 Avenham Place**

Nos.6 and 7 Avenham Place are a pair of two storey terraced dwellings, they are an appropriate size for their plot and relate to the adjacent terraced buildings along Avenham Place. There is no conflict between their scale and size. The pair is constructed from red brick with stone detailing and are generally in good condition, with some damp present on the brickwork of no.6. The pair has good quality stone detailing with moulded door cases with a cornice with dentil detailing on consoles. The ground floor windows have stone mullions in the form of pilasters, separating three arched windows. The first floor windows also have a cornice above with dentil detailing, though this has been removed from no.7. Brickwork is in English bond. The windows are of timber, two-over-two on the first floor and one-over-one on the ground floor. The doors are timber with six panels.

The materials compliment the other buildings found elsewhere in the conservation area. The windows and doors contribute to the character and appearance of the buildings, though not all appear to be original.

The buildings appear to be in their original form and retain their use as dwellings, with some alterations to the windows/doors. The pair of dwellings were built in the mid-later 19th century, slightly later than the buildings found elsewhere in this area. They reflect the continued expansion of Avenham during this time period. The dwellings have group value and collective character and detailing.

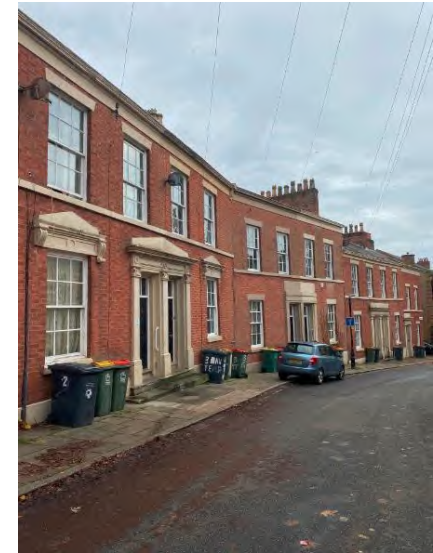
### **2-8 Avenham Terrace**

Appropriate sizing for plot, in keeping with sizing of surrounding terraced building. Red Brick buildings, material same as of that within the surrounding street. Moderate level of detailing and good distribution of openings, interest in the front elevation with opening recesses and detailed porch. Sash windows and original chimney breast.

Generally in good condition. Overall materials, form and detailing relate or identical to adjacent properties with large modern rear extension to the property.

Part of C19 expansion of the town (now City). In keeping with buildings within the street. Cobbled stone adds character to the end of street collective of buildings.

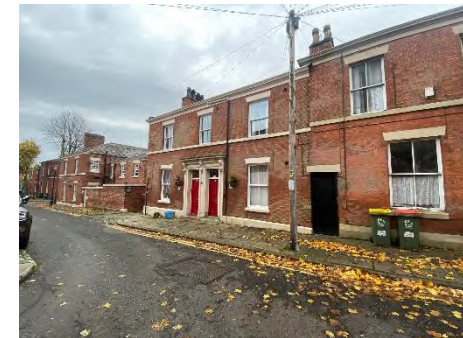
### **1-5 Cadogan Place**

Appropriate sizing for plot, in keeping with sizing of surrounding building. Relates to row of buildings on Cadogan Place. Red Brick buildings, material same as of that within the surrounding street. Good condition, looks to have been sandblasted to create cleaner finish on brick. Moderate level of detailing and good distribution of openings, interest in the front elevation with opening recesses and detailed porch. Sash windows and original chimney breast.

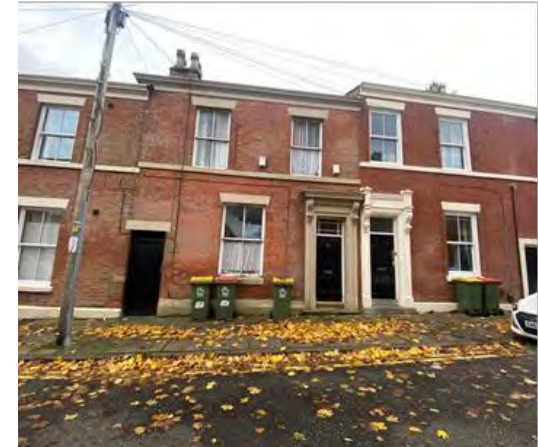
### **7-13 Cadogan Place**

Terraced houses, appropriate size for area and typical form of development in this part of the street. Red Brick buildings, material same as of that within the surrounding street. Good condition. Moderate level of detailing and good distribution of openings, interest in the front elevation with opening recesses and detailed porch. Sash windows and original chimney breast. Some windows in poor condition but overall, well-kept condition.

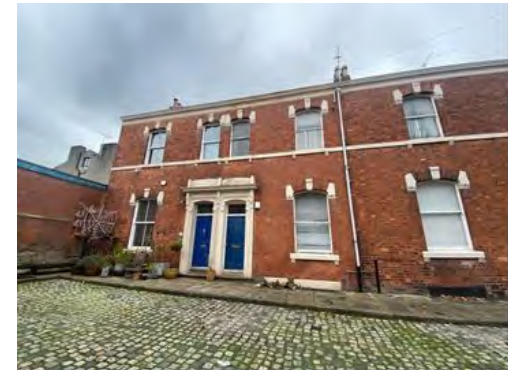
### **10-12 Cadogan Place**

Semi-detached as part of development of two identical pairs, and typical form of development in this part of street, appropriate scale for the area, relates to 50 Great Avenham Street. Buildings are not within conflict of one another. Red brickwork with chimney on roof. Timber white windows in good condition on property 12, could be improved on 10. Bands that run across windows overall in a good condition. Original chimney breast. Negative impact antenna to gable end. Strong architectural quality surrounding door frame.

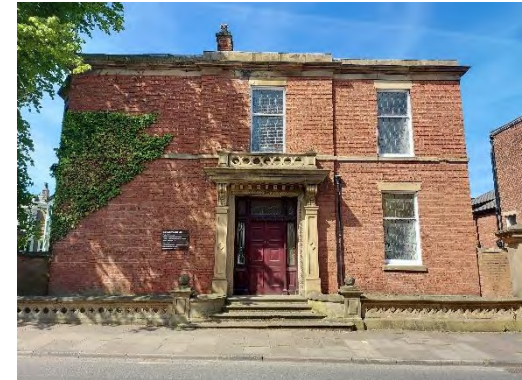
Good detailing, large-scale building. Central doorway (with window above) with panelled pilasters, corbels and prominent cornice topped with a parapet; door with six panels (square), transom window and side windows (all leaded). Wedge lintels on all windows – raised sills on all except ff sill-band on principal elevation. Three sets of tall windows with cornices on the northern elevation (gf and ff). Timber sash windows (one over one leaded Tudor style on principal elevation). Building in good condition. Significant ivy growth on the left side of the principal elevation. Ivy seen in historic photo. Two windows removed on the front elevation (gf, ff left). Traces of brick repair visible.

Has its own distinct style in terms of the prominent doorway and its decoration. Compliments and contributes to the appearance and character of the CA. The rear section of the building is not similar to how it was in the 1892 OS Map. Originally appears connected to 15 Ribblesdale Place. A slightly smaller building with a rear extension stretching as far as the rear of 15 Ribblesdale Place is shown in the 1847 OS Map. The present form is closer to that in the 1892 OS Map, when the building was possibly extended.

It is a prominent building at the eastern end of Ribblesdale Place where it meets Winckley Square. Sandstone front boundary wall with curved detail, curved brick wall and tall posts at either end. Originally with dwarf railings. Brick boundary wall with sandstone plinth attached to the left gatepost continues as far as the entrance to Avenham Park. To the right is a gate with timber double-door leading to a tarmac for parking. Shared with 15 RP?

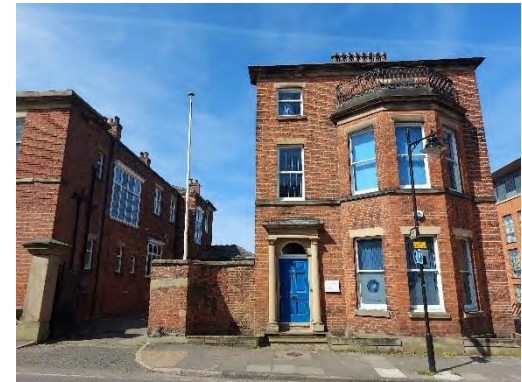
### **15 Ribblesdale Place+1a East Cliff**

Lost railings on boundary wall at the front. A car park between 14 and 15 RP (tarmac) with timber double-door. Alarm boxes and cables on East Cliff elevation slightly detract. 15 RP: Some brick and sandstone discolouration but overall in good condition. 1a East Cliff: large area of brick spalling on ground floor facing the street.

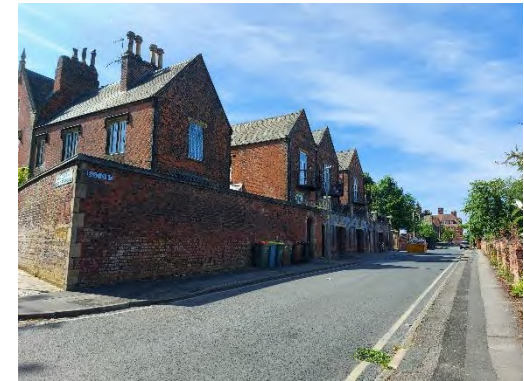
### 1-4 East Cliff

Converted into offices, then flats, No.1 re-converted into single-ownership. Garage doors added later. Major efflorescence issues in the boundary wall facing East Cliff, roof slates missing but the buildings appear in in good condition.

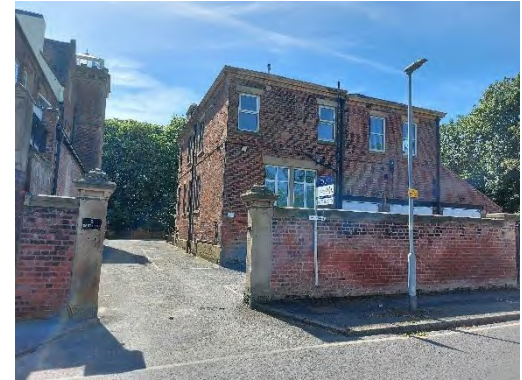
## 5 East Cliff

The more prominent elevations of buildings on East Cliff tend to be south-facing elevations overlooking Avenham Park, so the views from East Cliff mainly the rear elevations, as is the case here. The rear elevation slightly detracts due to the shed roofed extension. Efflorescence in brick, brick repair, small window blocked. Cables.

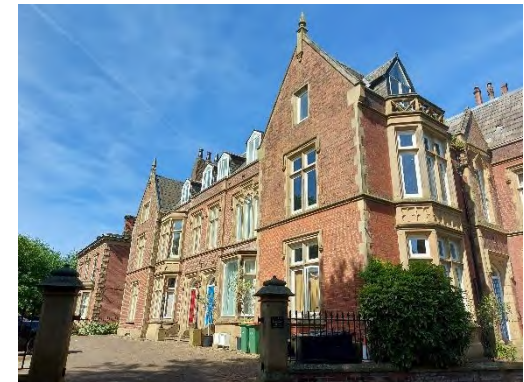
### **2-3-4 East Cliff Gardens**

Terrace of three buildings behind 1-4 East Cliff. Two storeys with attic. Red brick (English bond) with sandstone dressings. Timber casement windows, some possibly with shutters. Slate roof. Overall in good condition.

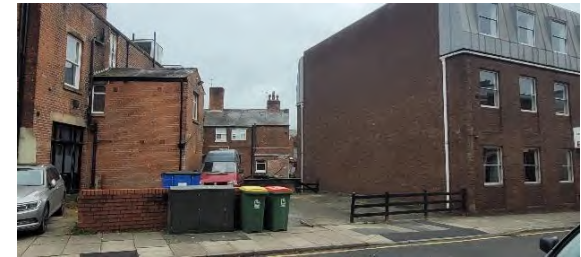
#### Area between 9 and 11 Starkie Street

Situated at the rear of 29a Ribblesdale Place, the area between 9 and 11 Starkie Street is used for parking. Originally, this used to be a garden to 29a Ribblesdale Place and is totally altered and taken over by hard surface for parking for the property. Lacking a high boundary wall, the area is fully visible from Starkie Street. The use of concrete hardstanding, timber fencing, a modern brick boundary wall, and metal parking posts form an incoherent appearance within the streetscape. The area is poorly maintained and is fronted with bins and modern telecoms/broadband box.

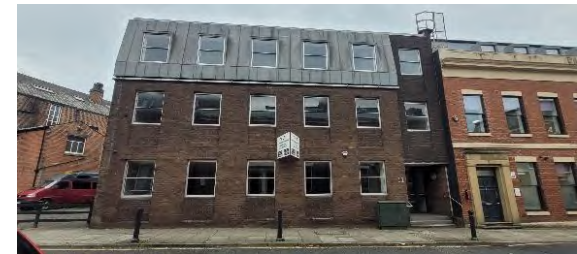
#### 11 Starkie Street

Vacant modern two storey building with an attic, which replaced a 19<sup>th</sup> century structure. It forms part of a row of terrace properties of different styles but does not provide any collective character or significance. Made of brown brick (Stretcher bond), the building has set back bricks to reveals under windows, and has modern sash windows and a panelled sheet Mansard roof. Built most likely for office use, the building is in contrast to rest of CA in terms of colour scheme and style, thereby detracting from its significance.

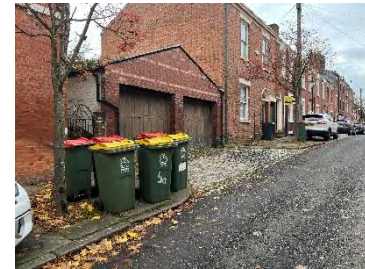
### The garage adjacent to 44 Great Avenham Street

Constructed from red brick and is relatively uniform. Historically this plot was a garden, most likely associated with 20 Latham Street, and the garage was built in the late 2000s to the part facing Great Avenham Street. Constructed from Stretcher bond brickwork, the garage has two timber garage doors. The stone sets on the front are in line with similar garage entries in the CA and other historic areas in Preston. The scale and gabled front elevation of the garage do not relate to the rest of the terrace or buildings opposite and the condition of the garage doors detract from the appearance of the CA.

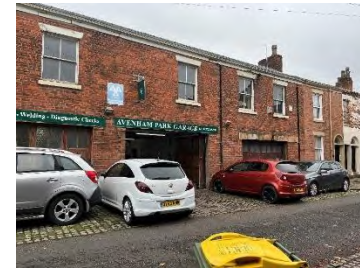
### 7-11 Great Avenham Street

Three early 19th-century mid-terrace houses. Their ground floors were converted into a van storage sometime in the 20<sup>th</sup> century and then turned into a workshop/garage, possibly in the 1980s or later. The upper floors retain their original terraced dwelling window positioning but the conversion resulted in three voids as wide as each of the original terrace houses to enable car entries. Although the brickwork and window detailing on the upper floor complement the buildings in the CA, the garage doors and signage on the ground floor, have a negative visual impact and disrupt the uniformity of the terraced row. Particularly the physical condition of building materials in 11 GA Street detracts from the visual appearance of the CA.

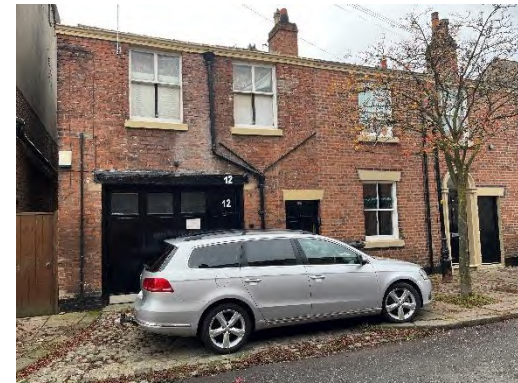
### **12 Great Avenham Street**

Very small two-storey building of red brick (4+1 English garden) with sandstone dressings and slate roof. No chimney stack. Between two sets of listed buildings (8-10 and 14-16-18). Single-fronted with through-lobby on the left (now 12a) with wedge lintel and board door. Original doorway, possibly round-arched similar to 8-10 GA Street, to the left of through-lobby door and the ground floor window replaced with wide garage door (black). Timber two over two windows with horns.

Possibly built with 8-10 GA Street c.1820. Building in poor condition, windows covered with cardboard?. Pointing with cement mortar on entire front elevation. Discoloration.

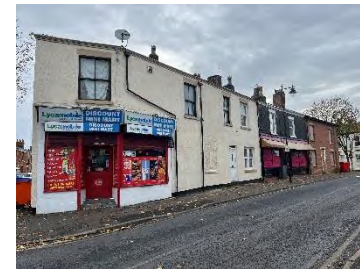
### **24-32 Avenham Lane and 68 Frenchwood Street**

A row of terraced buildings that sit on Avenham Lane, between Frenchwood Street and Great Avenham Street. No.26-32 Avenham Lane were converted into shops, which has changed their appearance and reduced their relation to other terraced dwellings in the area. The buildings still follow the height and some form of the terraced dwellings on the neighbouring streets but they appear to have been knocked together to create larger properties for the shops. No.24 Avenham was formerly a public house, The Avenham Park but is now vacant. Black painted brick at 26-28 Avenham Lane is detracting. No. 30 Avenham Lane, Preston used to be the home of Charles Hardwick when he wrote his "History of the Borough of Preston" in 1857 but the building bears no likeness to its original appearance.
