## Appendix A

### Key Historic Buildings within the Conservation Area - Listed Buildings

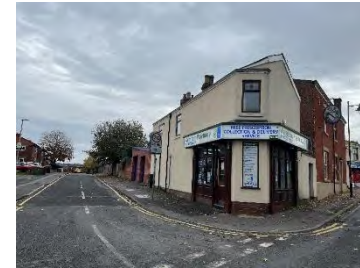
Two storey building of brick with cream-coloured render. Currently used as a pharmacy, it is a corner building dating to the early 19<sup>th</sup> century and was most likely built as a shop on the ground floor, similar to various other buildings in the city centre most of which have been lost. As a relatively rare survival, it still retains some of its shopfront elements but has largely lost its historic character due to the loss of architectural features and the use of incompatible materials and signage.

**42a Avenham Lane** was originally part of 42 Avenham Lane but is now accessed via a rendered boundary wall with a metal door. The two-storey building is timber clad and has a metal roof so it has seen considerable change. As a whole, these two properties visually detract from the appearance of the CA.
