Appendix A

Key Historic Buildings within the Conservation Area - Listed Buildings

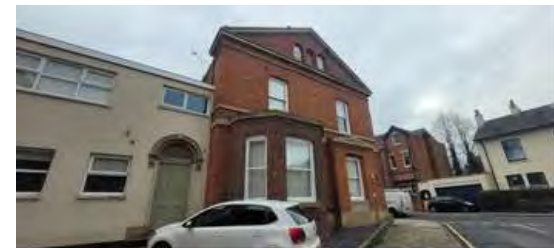
11 Camden Place

Two-storeys (rear part) and two-storey with attic. Constructed mostly of Flemish bond red brick with the exception of the canted bay window on Camden Place, which is Stretcher bond. Two-storey element is finished in render, painted cream. Stone detailing (painted). Slate roof. Timber 1 over 1 sash windows to brick part of building, white modern uPVC casements to rendered part. Traditional style timber door, with fanlight. Built in Classical style, with decorative stone details, including, arched door surrounds, gable pediment, bands and string course to FF, sills, brick lintels. Lunette window to attic on Ribblesdale Place elevation. Retained chimney stacks. All appear in residential use.

Largely retained its external features to brick part but rendered part substantially modernised, which detracts. The larger brick bay window is a later addition and would originally have matched the adjacent square bay, this is evidenced on the early town maps (1840s).

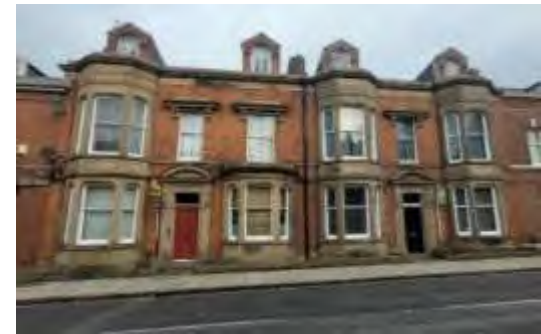
29-29a Ribblesdale Place

Two-storeys with attic, part of a row of terrace properties, different styles. 2 separate properties. Double fronted. Constructed of red brick (Flemish bond) with a slate roof. Decorative stone detailing. Curved timber 1 over 1 sash windows. Traditional style timber doors, with transom windows. Polychrome brick to attic dormers (red & blue?), vertically hung slates to sides. Decorative stone details, including canted bay windows (all but 1 double), decorative door surrounds with segmental pediment and window hoods, deep eaves cornice, sill band to FF. Retained chimneystacks. Small stone boundaries retained, no railings. Retained most original features. All appear to have residential use.

Forms part of a row of terrace properties, provides collective character, but differ in style. Part of C19 expansion of the town (now City). Later buildings on the row, identified on the 1840s-90s town map, not the earlier 1840s-60s.

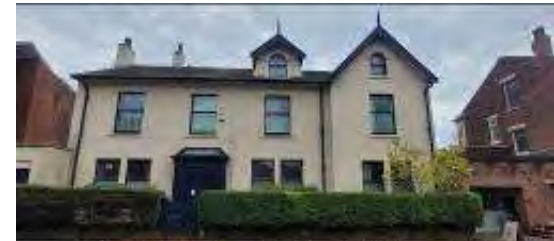
12 Ribblesdale Place

Two-storeys with attic, front-facing projecting gable and 1 x attic dormer windows, 4-bay detached property, different in style than majority of other buildings on this street. Most likely built from brick, now rendered with a slate roof. Some stone detailing evident under render to the dormer windows, with arched detailing. Timber 1 over 1 sash windows, curved in attic/dormer. Timber porch with traditional style timber doors, with transom windows. All timber painted blue. Stone details (curved) evident to attic windows under render. Timber finials to timber fascia's on dormer and gable. Retained chimneystacks. Most original features either lost or hidden. Small stone boundaries retained, with box hedges, which clearly define the garden space. Retained timber gate and posts, possibly original.

Use unclear, small sign on front elevation for Society of Saint Pius X. Once the home of Nathaniel Miller and family, who was a dentist but also financed the construction of Preston's Miller Arcade, to who it is named after.

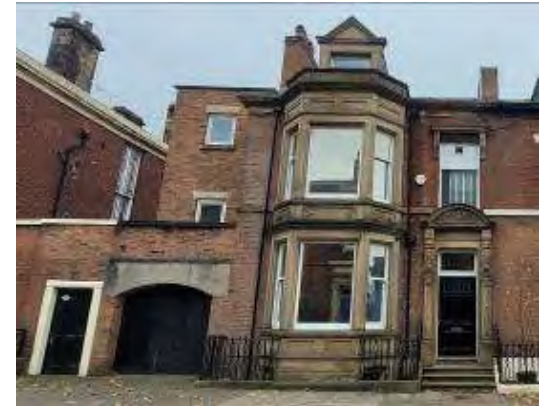
4 Ribblesdale Place

Two-storeys with attic and basement. Part of a terraced row. Constructed of red brick (Flemish bond) with a slate roof, later extension stretcher bond. Decorative stone dressings. Timber 1 over 1 sash windows and casement windows to central sections of bays, possible white uPVC to dormer, difficult to see, white uPVC to later extension. Stone sills and wedge lintels to side extension, sill band to ffl. Timber period style front door, with leaded transom window. Decorative classical architectural style, with the exception of side extension. Decorative stone details, including door surround with segmental arch, hoods to windows and deep eaves cornice, sill band to FF and stone faced dormer, with vertical hung slates to the side. Retained chimneystack and pots. Small stone boundaries retained, with decorative iron railings. Brick screen with timber entrance gates. Retained most original features. First ffl window altered and partially blocked up with a vent and alarm box detracts slightly. Use unclear, possible commercial use.

Part of C19 expansion of the town (now City). Earlier buildings on the street, identified on the 1840s-60s, at the time was semi-detached property, by 1840s-90s town map, become terraced. Provides collective character.

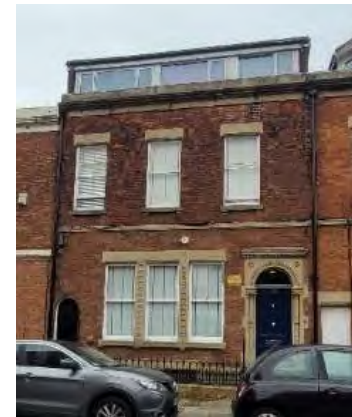
6a Starkie Street

Two-storeys with attic and basement, part of a row of terrace properties, slightly different in style. Red brick – Flemish bond and a slate roof. Decorative stone detailing. Timber 1 over 1 sash windows. Traditional style timber door, with fanlight. Decorative stone details, including mullions to GF windows, decorative arched door surround, deep eaves cornice, sills and lintels, band to FF. Small arched access door to rear. Small stone boundaries retained, with railings. Retained most original features. Large modern dormer roof, spanning width of property, detracts. Alarm boxes and electrical wires, which detract very slightly. Largely retained most of its external features. Appears to have residential use.

Part of C19 expansion of the town (now City). Later buildings in the CA, identified on the 1840s-90s town map, not the earlier 1840s-60s. Forms part of a row of terrace properties, provides collective character, but differs in style slightly.

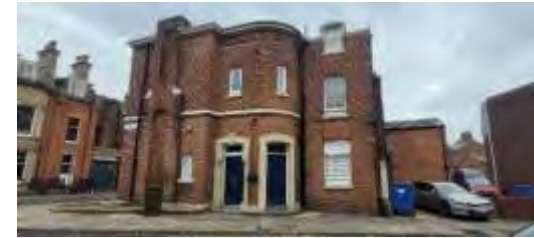
9 Starkie Street

Non-timber windows detract. Alarm boxes, electrical wires and satellite dish, detract very slightly. Rear/side open and hard surfaced, with patchy brickwork repairs and bin storage, which detract.

Part of C19 expansion of the town (now City). Later buildings in the CA, identified on the 1840s-90s town map, not the earlier 1840's-60s. Forms part of a row of terrace properties, provides collective character, but differs in style slightly.

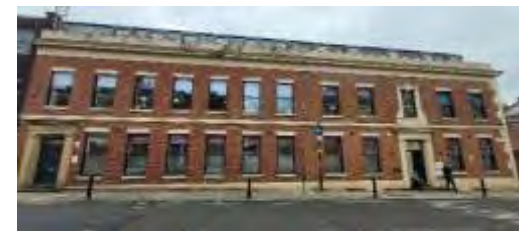
12-13 Starkie Street

Two-storeys with attic, part of a long row, 2 separate properties. Modern extensions added to the rear. Long rows of windows. Red brick – Flemish bond, modern roof difficult to see, possibly steel panelled. Stone detailing. Timber 1 over 1 sash windows. Traditional style timber doors, with transom windows. Modern sashes, painted positive. Decorative stone detailing, including sills and, lintels - wedge lintels to No.13, base plinth, deep eaves

cornice, band and decorative stone entrance doors, No.13 more impressive than No.12 doorway as runs into decorative FFI window.

Whilst large properties, possibly always of a commercial use, they reflect the long rows of terraced properties elsewhere, not put of place, as street is mixed scale, mass and style. Office use. Largely retained most of its external features Well maintained properties. Both restored, No.11 looks like bricks have been replaced or restored. Alarm boxes and commercial signs, which detract very slightly.

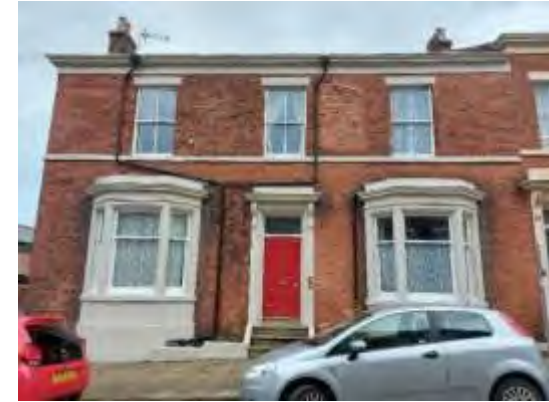
3 Bairstow Street

Two-storey plus basement. Corner of a terrace that continues all along Bairstow Street. Double-fronted. Canted bay windows on ground floor on either side of the central entrance. Rear garden accessed from the side (continuation of Bairstow Street). Very small extension to the rear (not visible from the street; can see from Mario Maps). Red brick (Flemish bond). Classical style sandstone dressings. Slate roof. Red brick chimney stack on left edge with two clay chimney pots (different styles: round base and square base). Timber 2 over 2 sash windows with horns. Three-stepped central entrance with nosings. Canted bay windows on ground floor (principal elevation) with parapets on top. Wedged lintels on all other windows. First-floor raised sill-band. Four-panelled door (red) with transom window (overlight). Doorway has a stone surround with a cornice hood carried on brackets/consols. Plain frieze and moulded gutter cornice. Original chimney stack, stepped with dentils at the top. Black uPVC rainwater goods.

Pale brick section to the right of central window on first floor but no change in brick pattern (possibly closed smaller window?). Building compliments the rest of the terrace. Mock windows but visually in keeping.

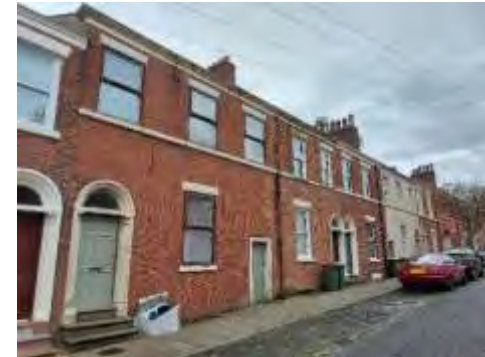
12-15 Chaddock Street

No.12 and 13 look run down, black discoloration along rain pipe, large-scale discoloration along the eave. No.14 and 15 good condition.

In its original form. Altered windows, removed cellar window. Built c.1830. Forms part of an almost complete set of late Georgian lower-middle class houses in this street. The pair is in between two pairs of listed townhouses.

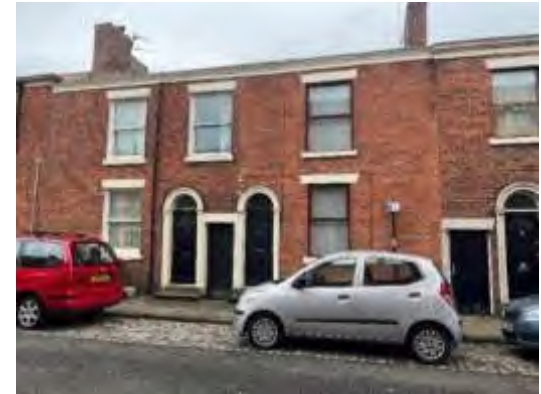
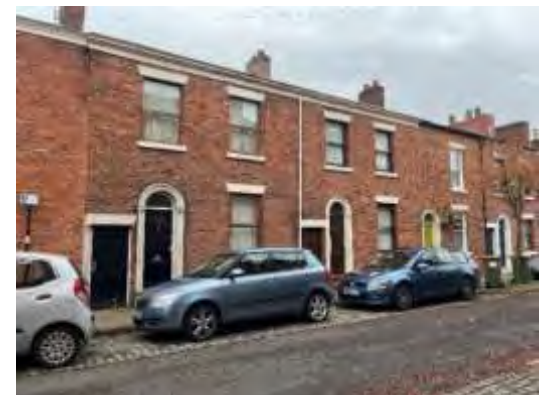
27-43 Great Avenham Street

Nos.27-43 Great Avenham Street are a row of terraced dwellings, they all follow the same design and form and as such there is not conflict between the buildings and they sit well along the street. The row is constructed from red brick with stone detailing. The dwellings are in an overall good condition, however there are some slight maintenance issues such as flaking paintwork and damp to the brickwork. No. 39 has had its brickwork painted red and no.43 has been rendered and painted cream, which disrupts the uniformity.

The brickwork alters along the row, and includes English garden wall bond and stretcher bond, the red brick colour also changes along the row. None of the windows appear to be original and are mainly mock sash in timber or uPVC. The front doors are mainly six panel timber doors, some of which are an arched window detail. The doors have an arched carved stone door case with a fanlight, this detail can be found across the row.

The building appears on the 1840s map and its use as a dwelling is still evident. The building reflects the historic expansion on the area. The overall form and arched door detail creates collective character between the dwellings and as such they have a good amount of group value.

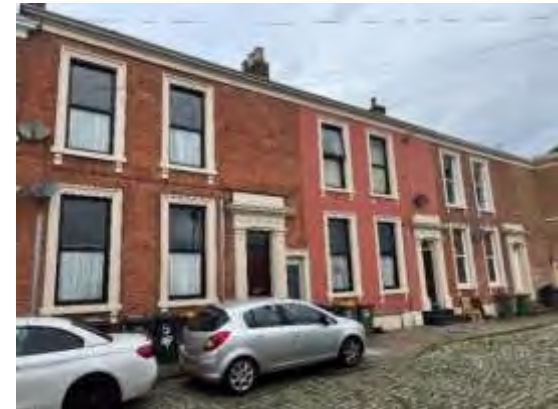
3-5 Avenham Place is a row of two storey terraced dwellings, they are an appropriate size for their plot and relate to the adjacent terraced buildings along Avenham Place. There is no conflict between their scale and size. The row is constructed from red brick with stone detailing, although no.4 is rendered and painted. Generally, they are in a good and uniform condition. The row has a good level of stone detailing, the door surrounds have pilasters with a plain frieze, moulded cornice with blocking course above. The brickwork is in English bond. Windows are sash/mock sash one-over-one and of timber, the front doors are a six panelled and of timber.

The materials compliment the other buildings found elsewhere in the conservation area. The windows and doors do not necessarily detract from the character or appearance of the conservation area as they are timber, though those at nos.3 and 4 are dark stained wood/black which differs from the neighbouring properties. There are some wires across the facades of the building as well as satellite dishes, which detract from the appearance of the row.

The buildings appear to retain their use as dwellings and are largely in their original form although most, if not all, of the windows and doors appear to be unoriginal. The group of dwellings were built in the mid-late 19th century, slightly later than the buildings found elsewhere in this area. They reflect the continued expansion of Avenham during this time period. The dwellings have group value and collective character and detailing.

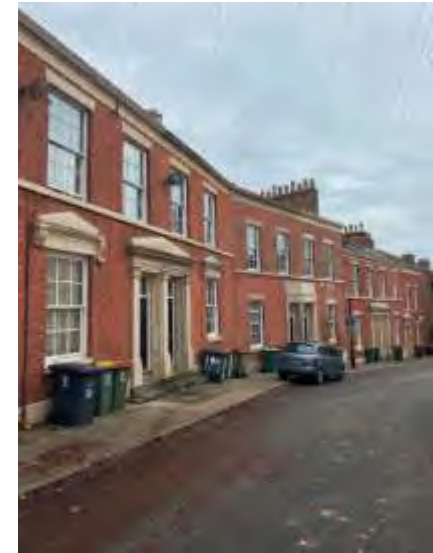
1-5 Cadogan Place

Appropriate sizing for plot, in keeping with sizing of surrounding building. Relates to row of buildings on Cadogan Place. Red Brick buildings, material same as of that within the surrounding street. Good condition, looks to have been sandblasted to create cleaner finish on brick. Moderate level of detailing and good distribution of openings, interest in the front elevation with opening recesses and detailed porch. Sash windows and original chimney breast.

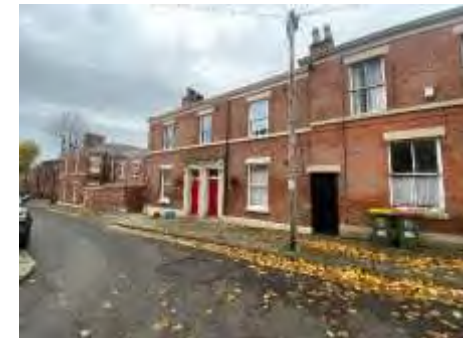
7-13 Cadogan Place

Terraced houses, appropriate size for area and typical form of development in this part of the street. Red Brick buildings, material same as of that within the surrounding street. Good condition. Moderate level of detailing and good distribution of openings, interest in the front elevation with opening recesses and detailed porch. Sash windows and original chimney breast. Some windows in poor condition but overall, well-kept condition.

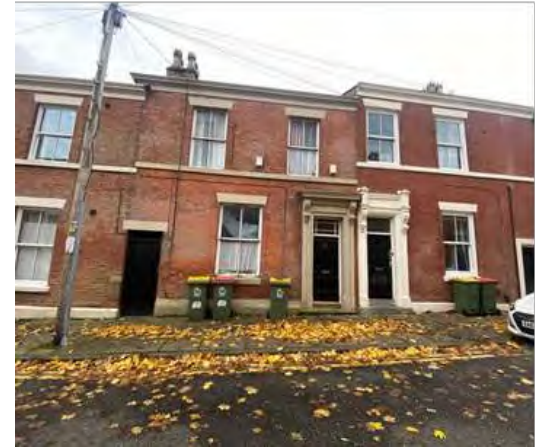
10-12 Cadogan Place

Semi-detached as part of development of two identical pairs, and typical form of development in this part of street, appropriate scale for the area, relates to 50 Great Avenham Street. Buildings are not within conflict of one another. Red brickwork with chimney on roof. Timber white windows in good condition on property 12, could be improved on 10. Bands that run across windows overall in a good condition. Original chimney breast. Negative impact antenna to gable end. Strong architectural quality surrounding door frame.

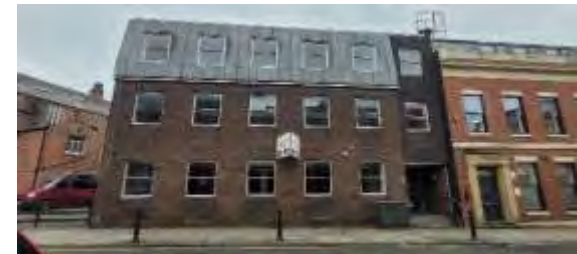
11 Starkie Street

Vacant modern two storey building with an attic, which replaced a 19th century structure. It forms part of a row of terrace properties of different styles but does not provide any collective character or significance. Made of brown brick (Stretcher bond), the building has set back bricks to reveals under windows, and has modern sash windows and a panelled sheet Mansard roof. Built most likely for office use, the building is in contrast to rest of CA in terms of colour scheme and style, thereby detracting from its significance.

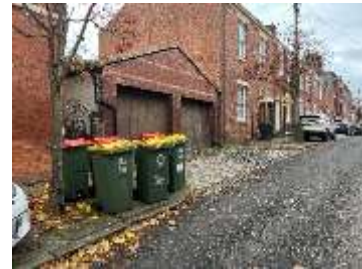
The garage adjacent to 44 Great Avenham Street

Constructed from red brick and is relatively uniform. Historically this plot was a garden, most likely associated with 20 Latham Street, and the garage was built in the late 2000s to the part facing Great Avenham Street. Constructed from Stretcher bond brickwork, the garage has two timber garage doors. The stone setts on the front are in line with similar garage entries in the CA and other historic areas in Preston. The scale and gabled front elevation of the garage do not relate to the rest of the terrace or buildings opposite and the condition of the garage doors detract from the appearance of the CA.

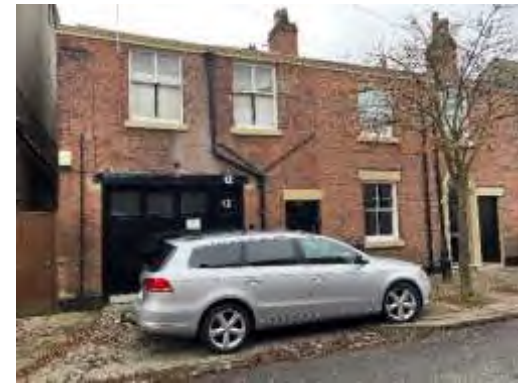
12 Great Avenham Street

Very small two-storey building of red brick (4+1 English garden) with sandstone dressings and slate roof. No chimney stack. Between two sets of listed buildings (8-10 and 14-16-18). Single-fronted with through-lobby on the left (now 12a) with wedge lintel and board door. Original doorway, possibly round-arched similar to 8-10 GA Street, to the left of through-lobby door and the ground floor window replaced with wide garage door (black). Timber two over two windows with horns.

Possibly built with 8-10 GA Street c.1820. Building in poor condition, windows covered with cardboard?. Pointing with cement mortar on entire front elevation. Discoloration.
